Ammonia Refrigeration – Faulty Solenoid Valve Alert

Safety Recall of Certain Sporlan/Refrigerating Specialties MA17 Solenoid Valves

MA17 Valve Date Code Identification Procedure

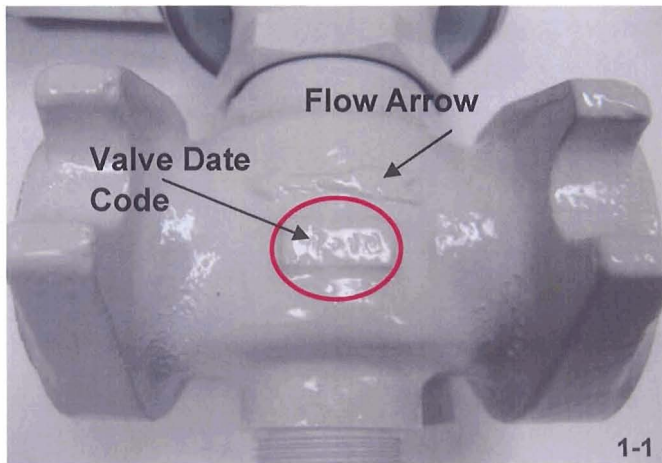
1. Locate the flow arrow cast into the valve body approximately 1" below the tube locknut. See photo 1-1.
2. Below the flow arrow is a cast, upraised boss where the valve date code is stamped. See photo 1-1, date code boss is highlighted with red circle. This boss may be located behind a flange through bolt. See photo 1-2 below.
3. Please note that the date code was designated by month (i.e., 1 through 12) prior to October 2008. Thereafter, the date code was designated by week (i.e., 1 through 52). The date code will appear as the following:

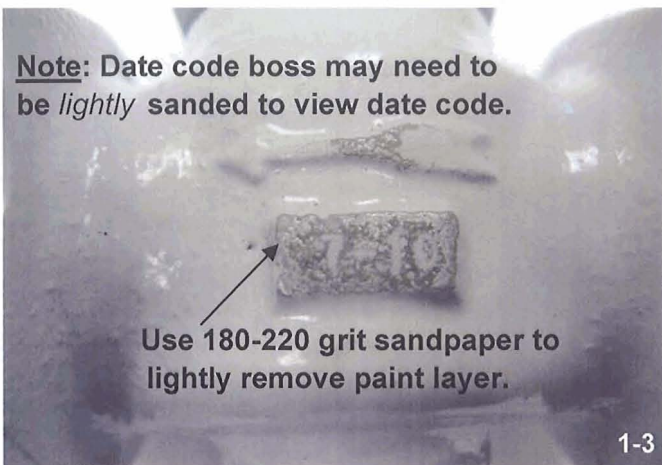
4. If date code is illegible due to epoxy paint, the paint can be removed using 180-220 grit sandpaper. *Lightly* sand date code boss to remove paint layer. Care must be given such that excess material is not removed. Date code may be rendered illegible if too much material is removed from casting. See photo 1-3 below.
